GLEASON LAKE MANAGEMENT PLAN

**Prepared for the Gleason Lake
Improvement Association**

**Prepared By
Emmons and Olivier Resources, Inc.
651 Hale Avenue
Oakdale, MN 55128**

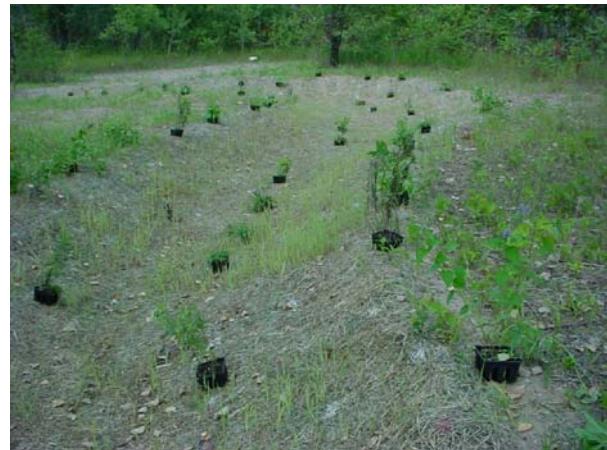
Luce Line Zero Runoff Pilot Demonstration Site.

Conversely, the Luce Line Trail DNR parking lot (Appendix A, Figure A2) is a high visibility site, with a moderate runoff treatment potential. This site was selected because it lends itself very well to retrofitting the parking lot with a filter and a vegetated infiltration system. The parking lot slopes to the southeast and to the northwest into low-lying areas extending along the parking lot. Between the lot and the two treatment areas, a vegetative and/or gravel filter could be installed to filter out solids. Since this parking area formerly was a sand and gravel mine, it is expected that water will readily infiltrate. Overflow, although not expected, could be routed to a City of Plymouth storm sewer that parallels the Luce Line Trail near the lot; this would be an option for consideration, if needed. Signage on the path leading from the lot to the Trail and on the Trail itself will pull trail users over to view the project. This site is also within walking distance of both Gleason Elementary and Wayzata Central Middle Schools. Because of the many benefits accruing from the Luce Line site, the Luce Line Pilot Project (LLPP) was chosen by GLIA representatives (Keeley and Palm) as the best option. Grant funds were sought and received from the Metropolitan Council, MCWD, City of Plymouth and Luce Line Trail Association, and the DNR allowed the site to be built on its land. The project was installed during the summer of 2003.

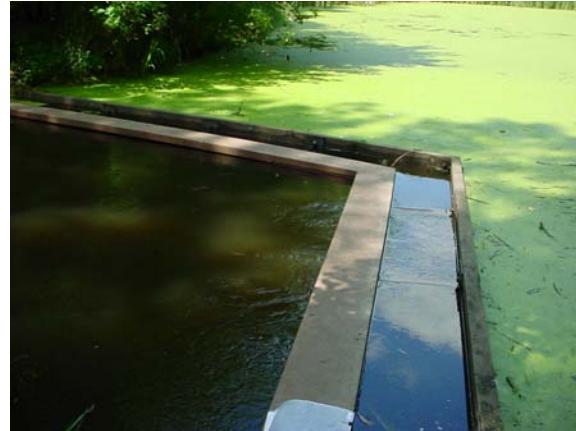
GLC-1, 2, 3, 4, 5 and 6 - All of the upper part of the Gleason Lake watershed comes together in GLC-6. The MCWD detention pond (see photo to right) located between Co. Rd. 6 and Gleason Lake is within this sub-basin.

However, the detention pond is approximately one-quarter of an acre in size, draining an area of approximately 1640 acres, resulting in an extremely low ratio of only 0.02%. The result of the very low pond-to-drainage area ratio is that the pond is overwhelmed by flow, and rendered generally ineffective because of the large volume of water scouring anything that might be deposited from baseflow. Preliminary work on the pond by the WD yielded an estimate of 12% effectiveness for

TP, but even this low figure is not considered accurate because of its small size. No reduction in TP load is expected for this pond. It should become the focus of a future BMP enhancement because of its key location relative to the watershed draining to the Lake.
